HVS-NORDIC

The activity of the second period in Finland 2000 - 2003

Finnra Reports 45/2003

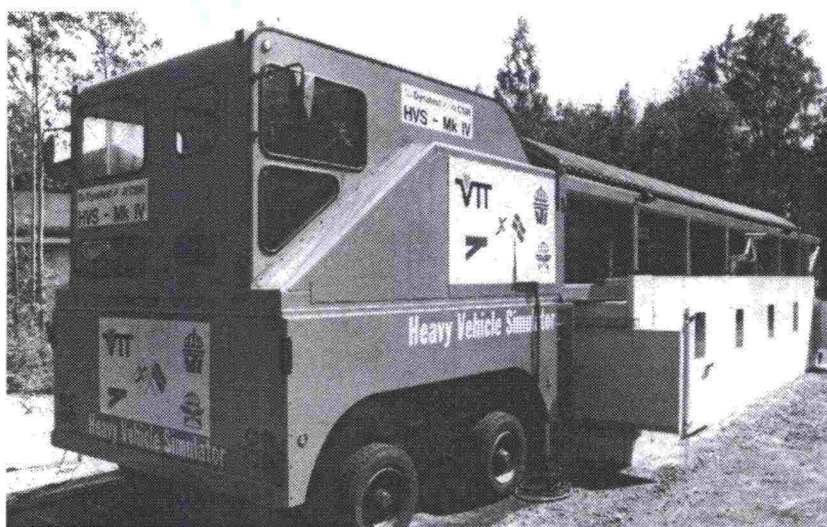
The machine is called HVS-NORDIC. The HVS Mark IV is a mobile full-scale accelerated pavement testing facility (Figure 1.1), whose loading is linear. It can be run over a short distance independently at walking speed, though in practice only at a specific test site. It can be moved as a semi-trailer over longer distances.

Figure 1.1. HVS-NORDIC accelerated pavement testing facility.

The HVS-NORDIC has a heating/cooling system and, thus, the temperature can be kept constant. The air temperature inside the heating/cooling box is controlled in order to keep the pavement temperature constant. The selected standard temperature of the bituminous layers was $+10^{\circ}\text{C}$.

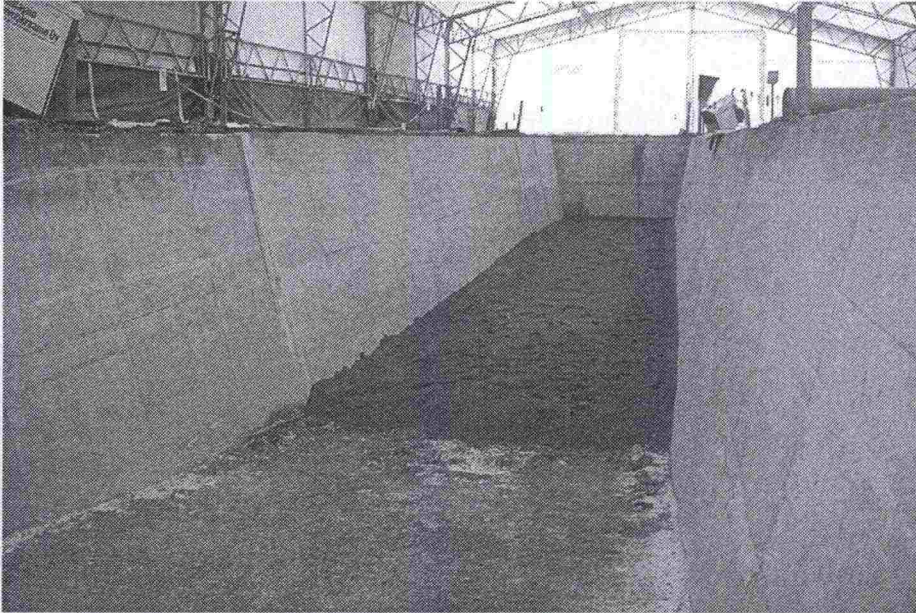
The test site is located a few hundred metres from the VTT office. The site includes two test basins. One test basin is made of concrete; the walls have thermal insulation and there is complete water table regulation (Fig 1.2). Its length is 36 m including a 16-m-long slope and its depth is 2.5 m and width 4 m at the top and 3 m at the bottom. Two or three test pavements can be constructed in the test basin.

Figure 1.2. Concrete basin in Otaniemi.
